TRIP REPORT

SITE NAME AND LOCATION: General Motors
3900 Motors Industrial Way
Doraville, Georgia 30360-3163
EPA I.D. No. GAD003310810

REFERENCES: Compliance Evaluation Inspection (CEI)

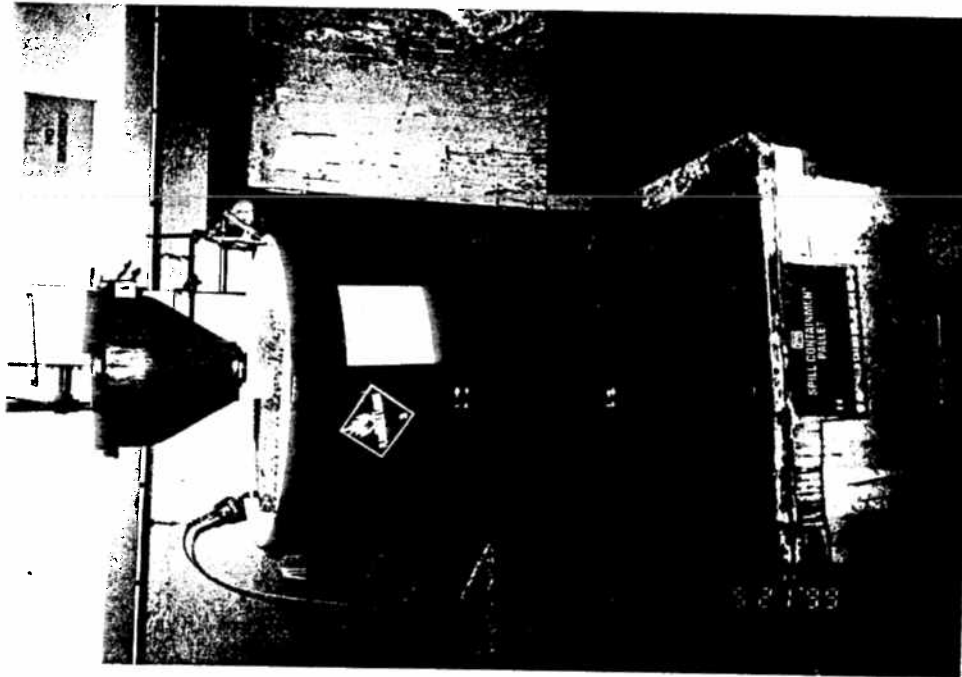
EXPLANATION: Satellite accumulation drum for the spray booth touch-up bays.

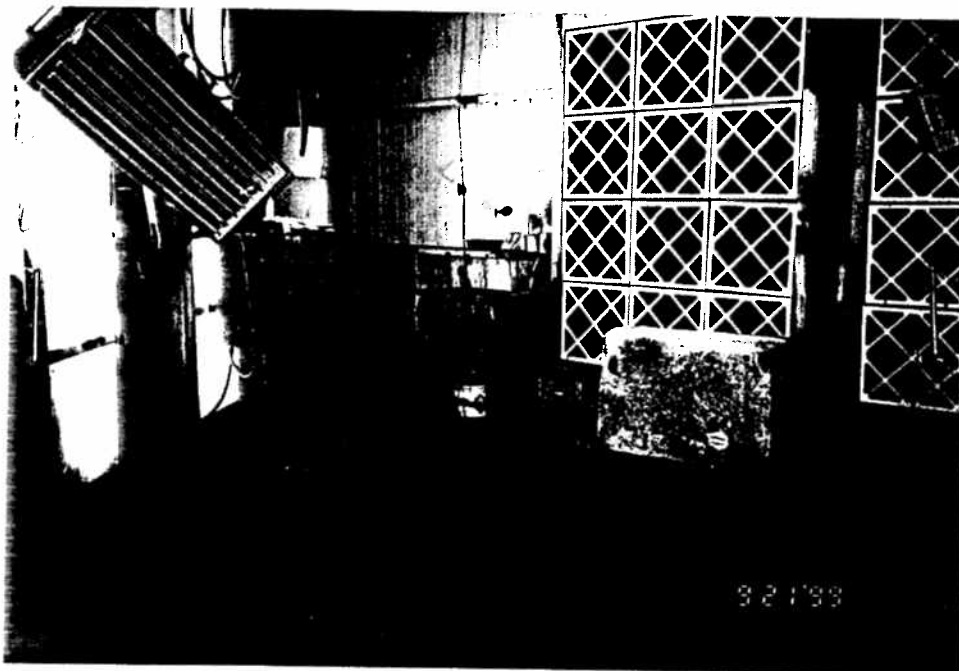
EXPLANATION: Spray booth touch-up bay. Seven of these bays exist. The spray gun cleaner box is the red container along the back wall.

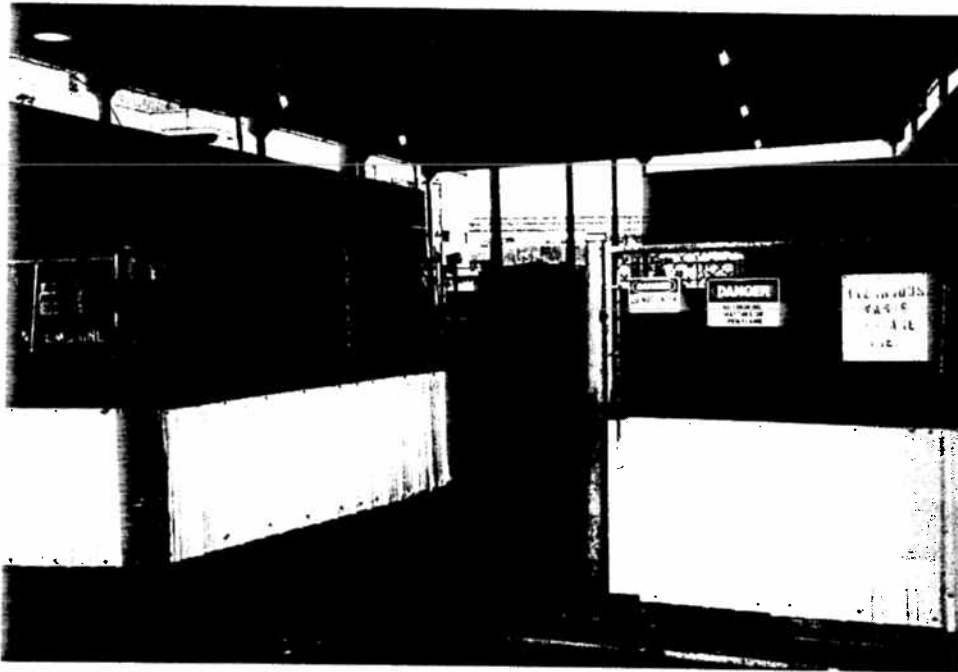
EXPLANATION: Hazardous waste less than 90 day accumulation area.

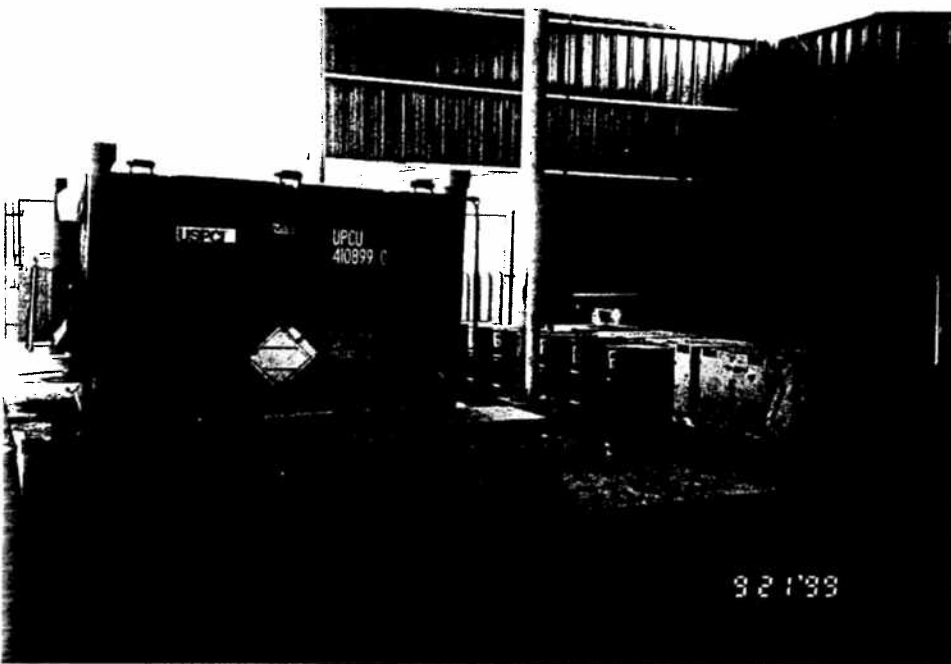
EXPLANATION: Hazardous waste accumulation area. The ELPO filter bags are accumulated in the roll-off container.

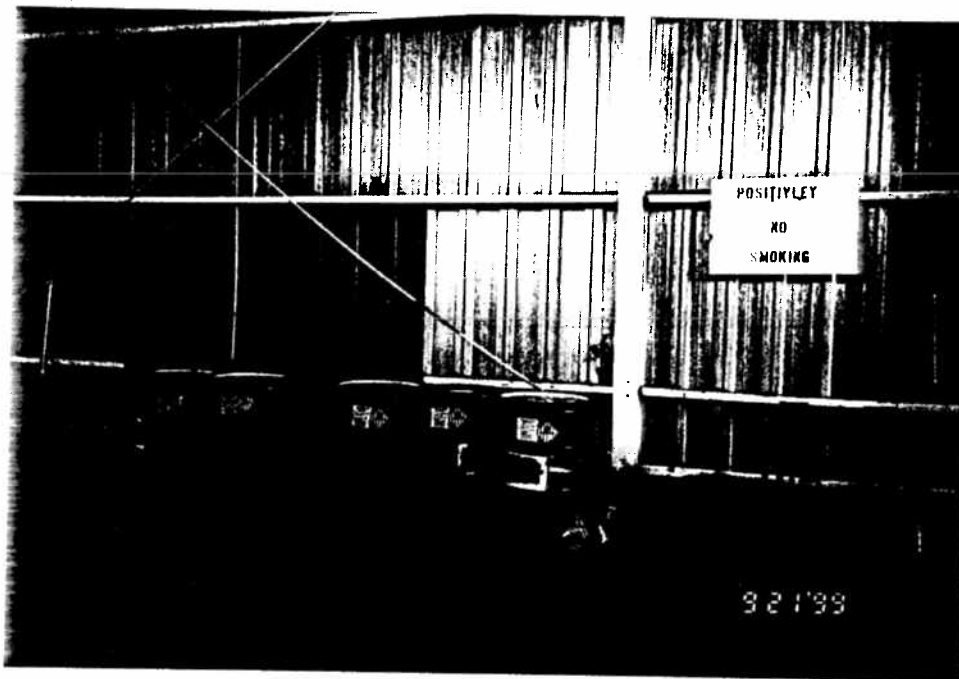
EXPLANATION: Hazardous waste accumulation area. Waste solvent / paint related material is in the drums.

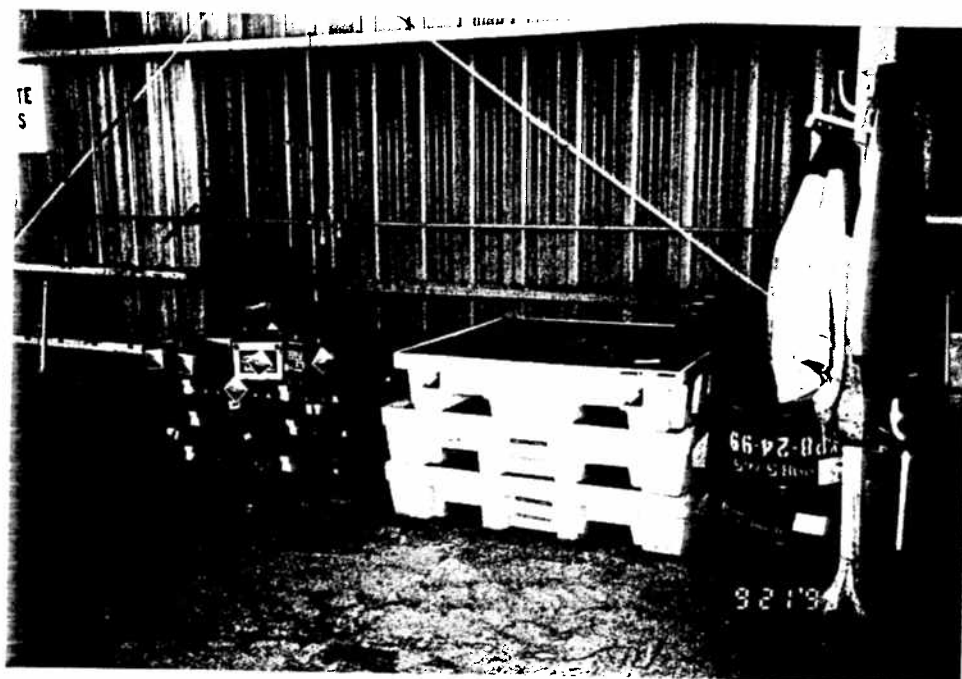
EXPLANATION: Hazardous waste accumulation area. Waste lead acid batteries are accumulated on the spill contained pallets.

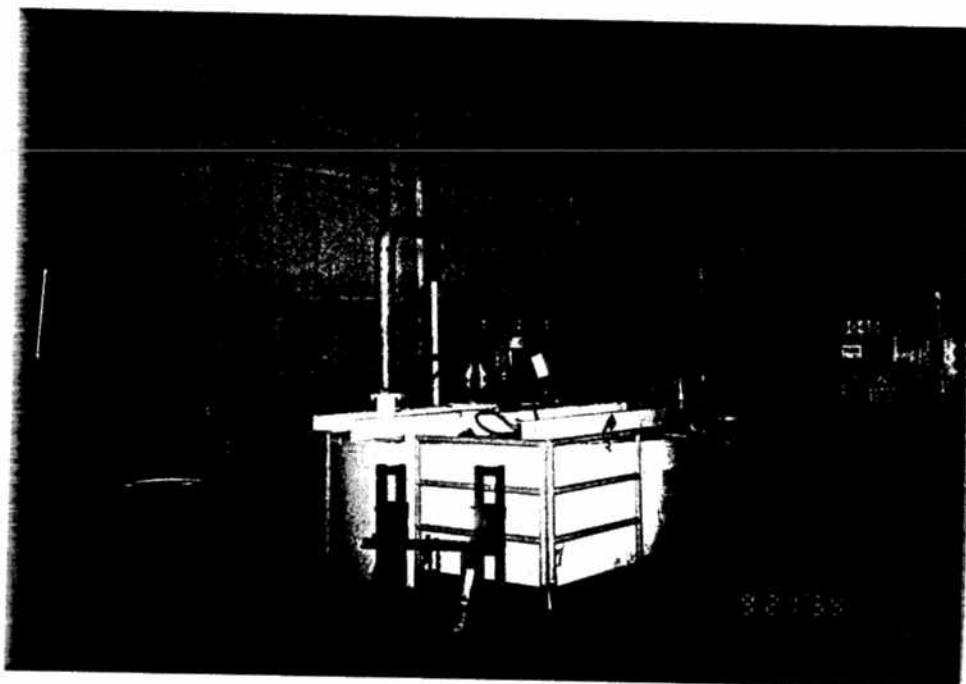
EXPLANATION: The white tank is the waste purge thinner tank. The silver tank is for virgin solvent.

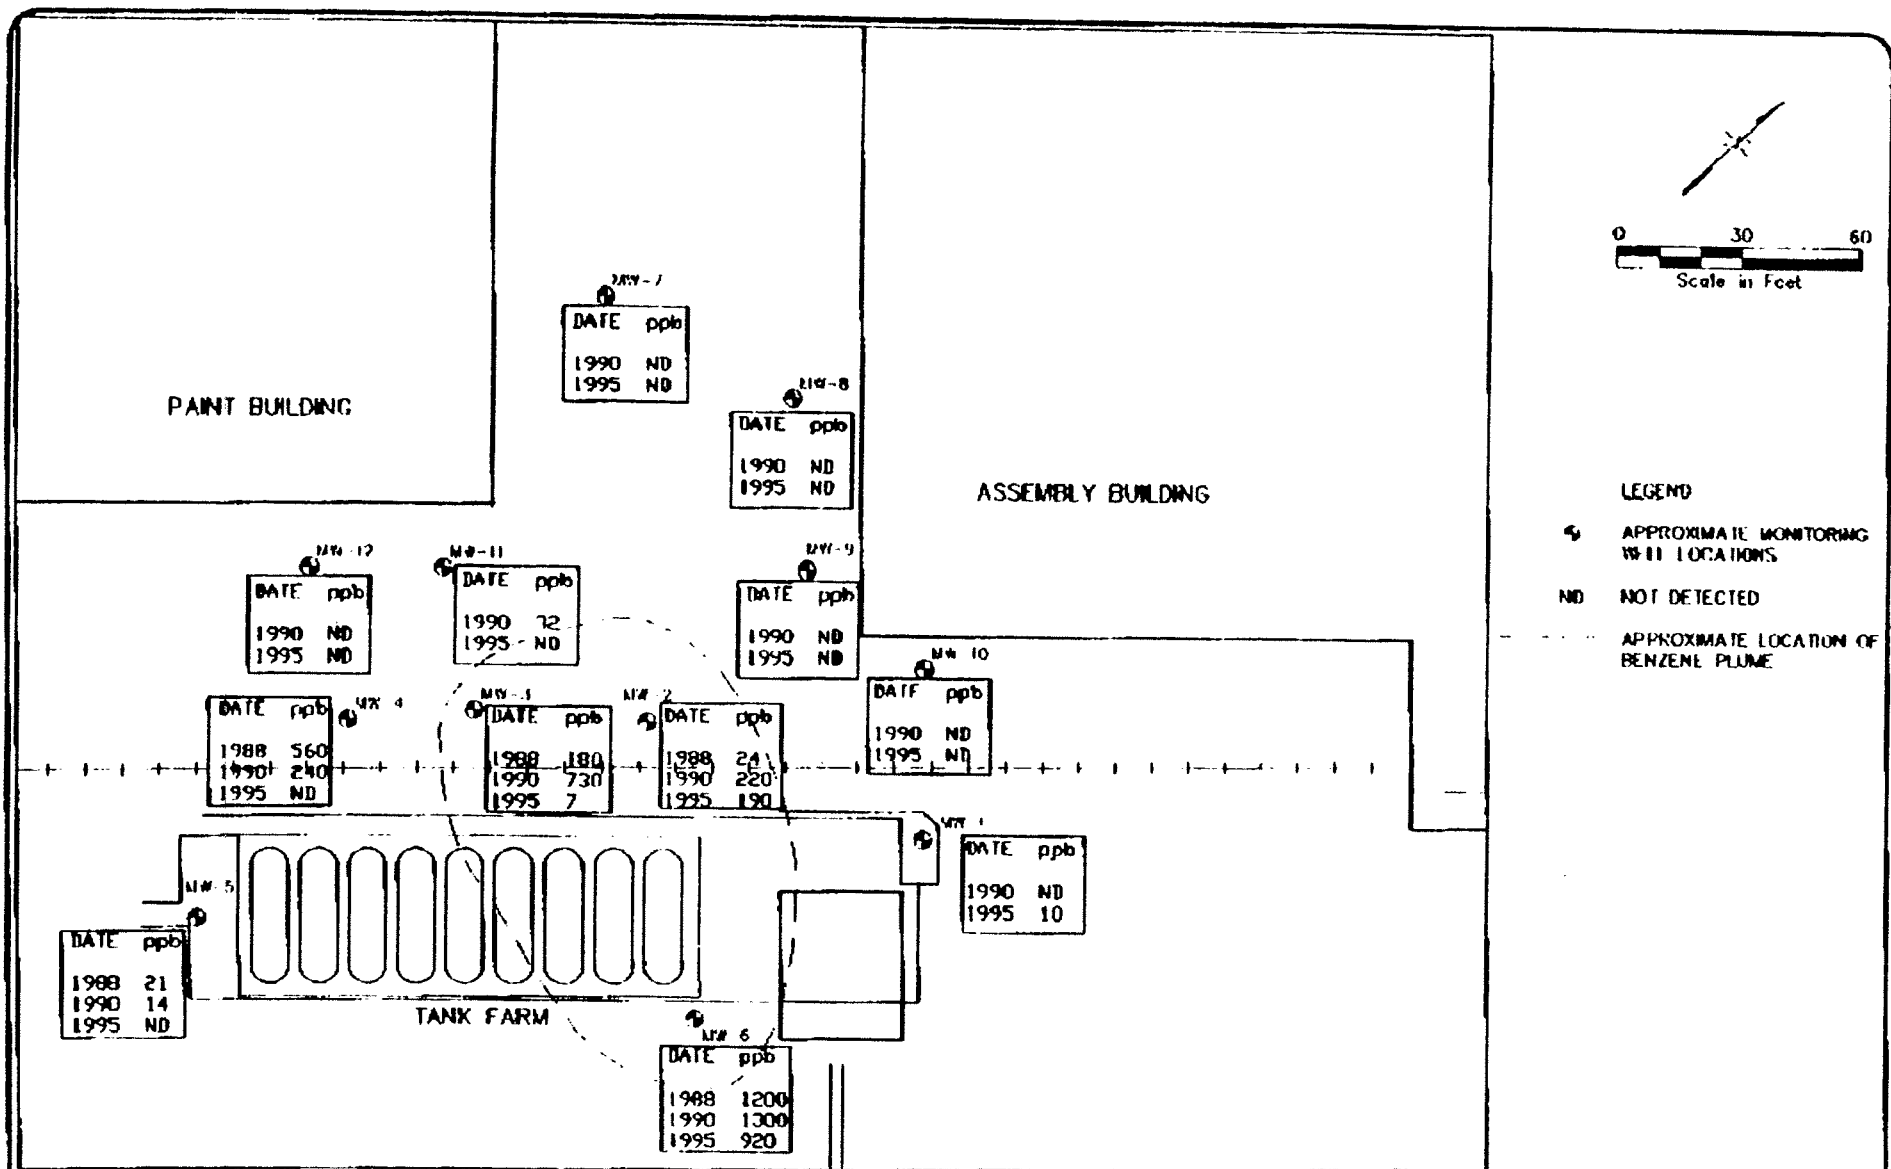
BENZENE CONCENTRATIONS IN GROUNDWATER (ppb)
 GENERAL MOTORS CORPORATION
 DORAVILLE, GA

Several investigations were conducted at the Tank Farm between 1988 and 1995 (AT&E 1990; Weston 1999). The results of these investigations indicated the presence of benzene and other petroleum-related constituents in shallow ground water. However, benzene is the only
